**DAMPER RETROFIT OF THE LONDON MILLENNIUM  
FOOTBRIDGE – A CASE STUDY IN BIODYNAMIC DESIGN**

**Douglas P. Taylor, President  
Taylor Devices, Inc.  
90 Taylor Drive  
North Tonawanda, NY 14120-0748**

### **ABSTRACT**

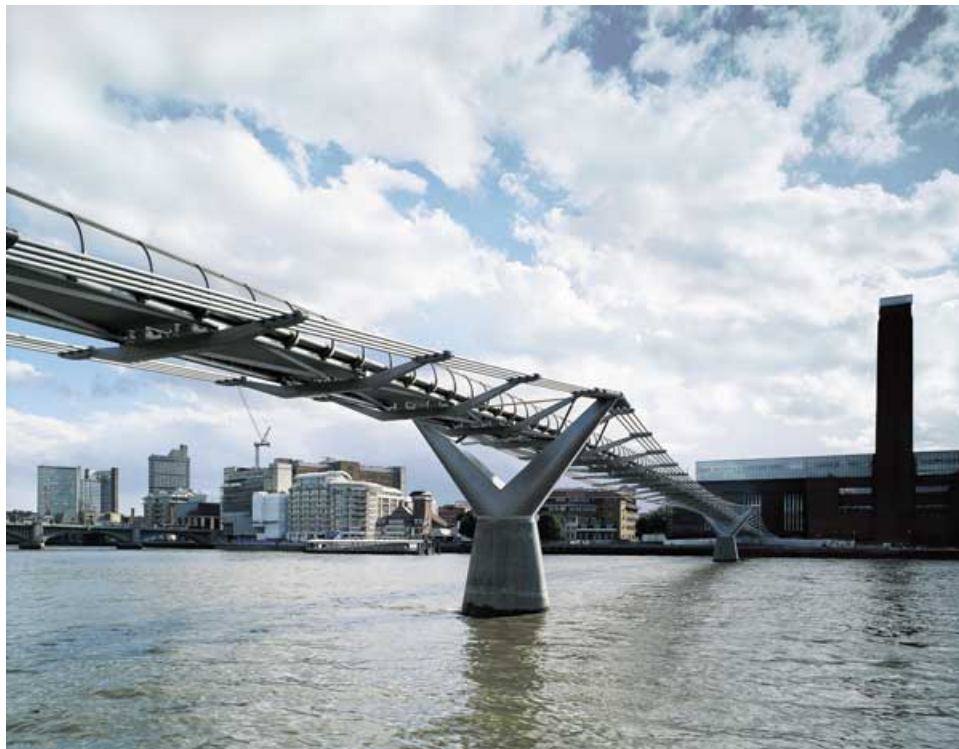
**FIGURE 1  
THE MILLENNIUM BRIDGE**

The bridge design team elected to use lateral suspension cables, where the cables are located at the level of the bridge deck. Two piers are located in the river, with a main span of 144 m between piers, and end spans of 81 m on the north and 108 m on the south. The bridge deck is 4 m wide, and uses articulated sliding joints spaced at regular intervals along its length. The architectural design theme for the Millennium Bridge is that of a “Blade of Light”; expressed and exemplified by the slender, ribbon-like cross section of the structure. A photograph of the bridge is provided as Figure 1.

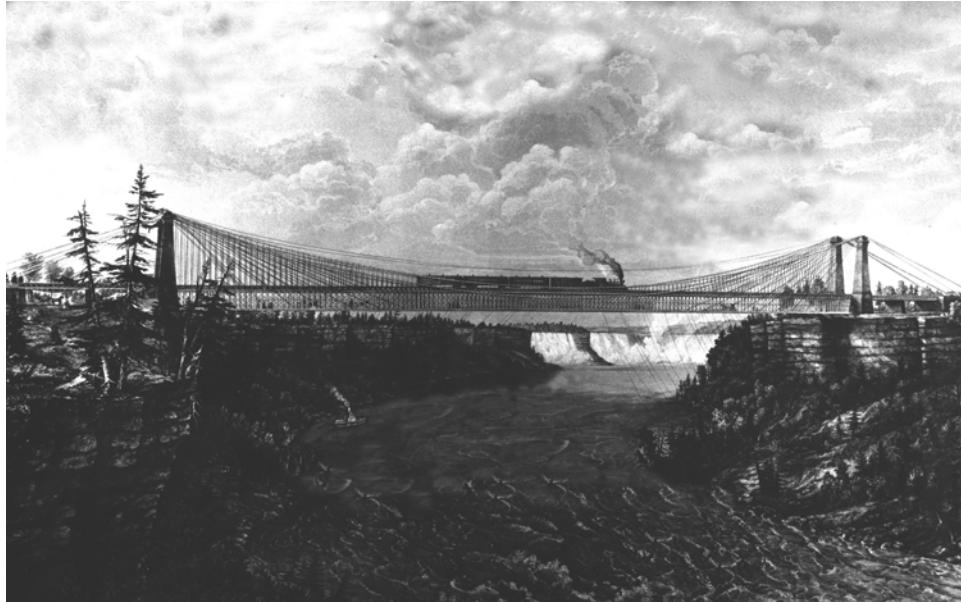
**FIGURE 2**  
**JOHN ROEBLING'S RAILWAY SUSPENSION BRIDGE AT NIAGARA FALLS, NY – 1854**

The phenomena of forced harmonic excitation of bridge structures is well understood, and has been well documented by many sources. Most military manuals dating back well into the 1800’s have warnings about soldiers marching in step over bridges of any type. This was true even for substantial bridges. For example, in 1860 the famous 1854 Roebling two-deck railway suspension bridge across the Niagara River at Niagara Falls, NY USA was posted with a warning notice to pedestrians against walking in-step. This heavily built, record-setting span is depicted in Figure 2, from an 1850’s engraving. The warning notice, reproduced from period photographs, is shown in Figure 3.

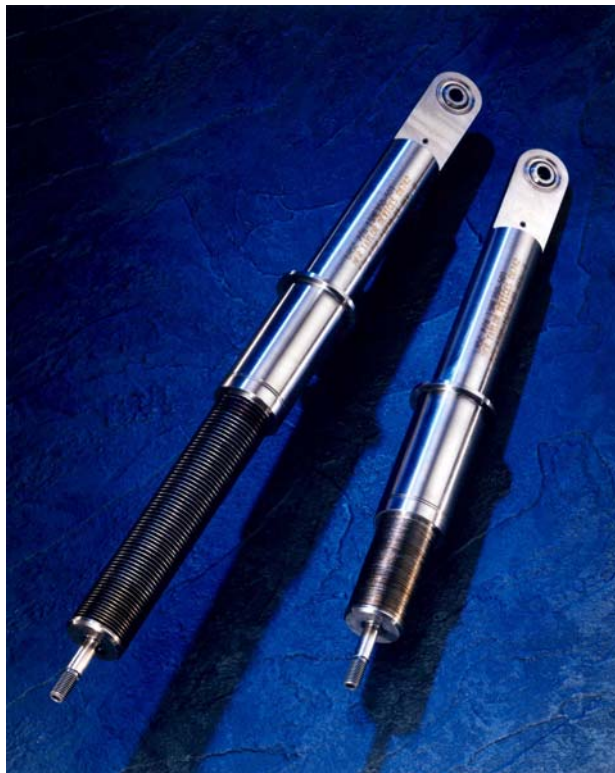
**FIGURE 4**  
**SPACE SATELLITE DAMPER**

Taylor Devices, a 50 year old manufacturer of damping products, proposed a unique solution to the damper design requirements for the Millennium Bridge. To address the various design issues, a unique and patented damper was proposed, previously used exclusively by NASA and other U.S. Government agencies for space based optical systems. These previous applications had similar requirements for long life and high resolution at low amplitudes, but required relatively low damper forces from small, lightweight design envelopes. Figure 4 is a photograph of a typical damper of this design, used in space on more than 70 satellites to protect delicate solar array panels. Figure 4 also shows the most unique element of this design, a frictionless seal made from a welded metal bellows. This type of seal does not slide, but rather flexes without hysteresis as the damper moves.

To adapt this basic design to the Millennium Bridge largely involved simply scaling the small satellite dampers to the required size range. All parts, including the metal bellows, were designed with low stress levels to provide an endurance life in excess of  $2 \times 10^9$  cycles. The metal bellows and other moving parts were constructed from stainless steel for corrosion resistance.

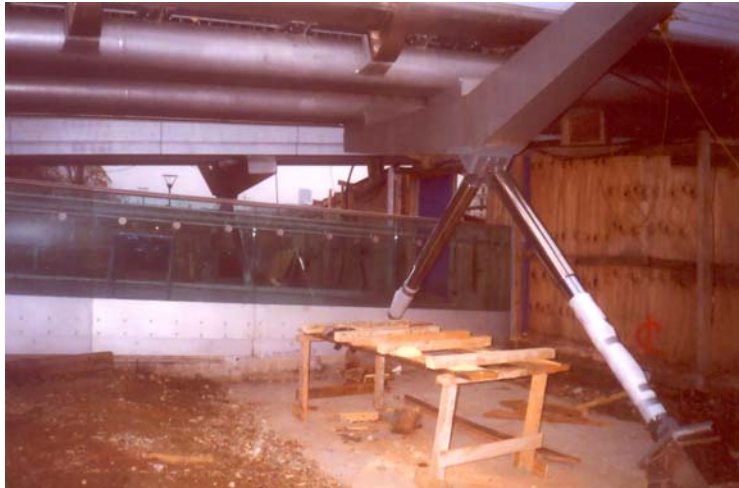
**FIGURE 7  
VERTICAL DAMPERS**

All dampers were fabricated and delivered to the bridge site in 2001, and testing of the structure with groups of pedestrians began in January 2002. Figures 7 through 9 are a sampling of the installed dampers.

To assure a high resolution output, it was required that all damper attachment clevises be fabricated with fitted spherical bearings and fitted mounting pins, such that zero net end play existed in the attachment brackets.
