**SEISMIC REHABILITATION OF HISTORIC CONCRETE STRUCTURE  
WITH FLUID VISCO-ELASTIC DAMPERS**

**Marr Shaffer & Miyamoto, Inc.**

# **Seismic Rehabilitation of Historic Concrete Structure With Fluid Visco-Elastic Dampers**

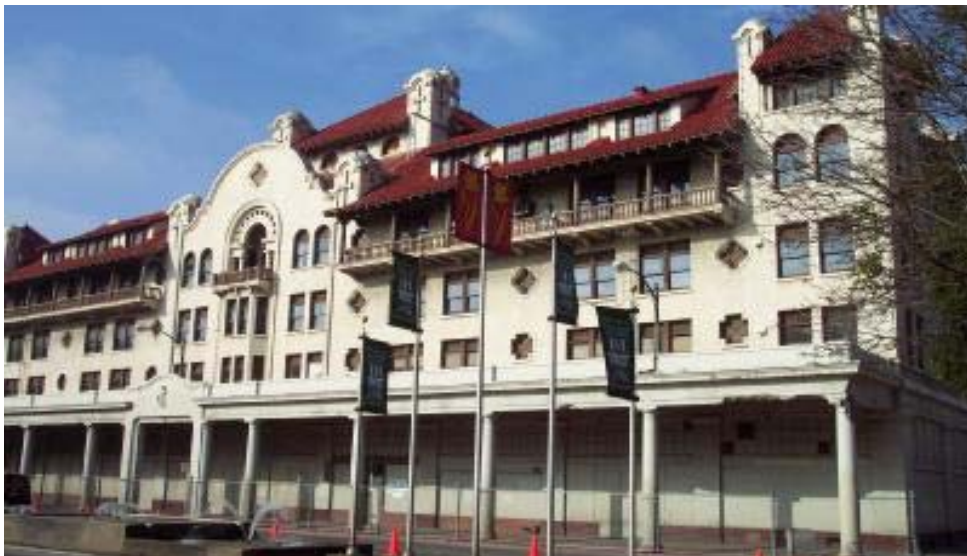
E-W direction and 100 ft (30.5 m) in the N-S direction. In elevation, it is comprised of a six-story portion on the east side and a two-story portion on the west side, and has a full basement. The first story is 18 ft (5.5 m) high and the remaining floors have a story height of 10'-3" (3.1 m). Figure 1 below shows a south elevation of the eastern portion of the building.

**Figure 1: South Elevation**
